UG Fire Construction Storage 44 Level

Red Lake Gold Mines
April 2019

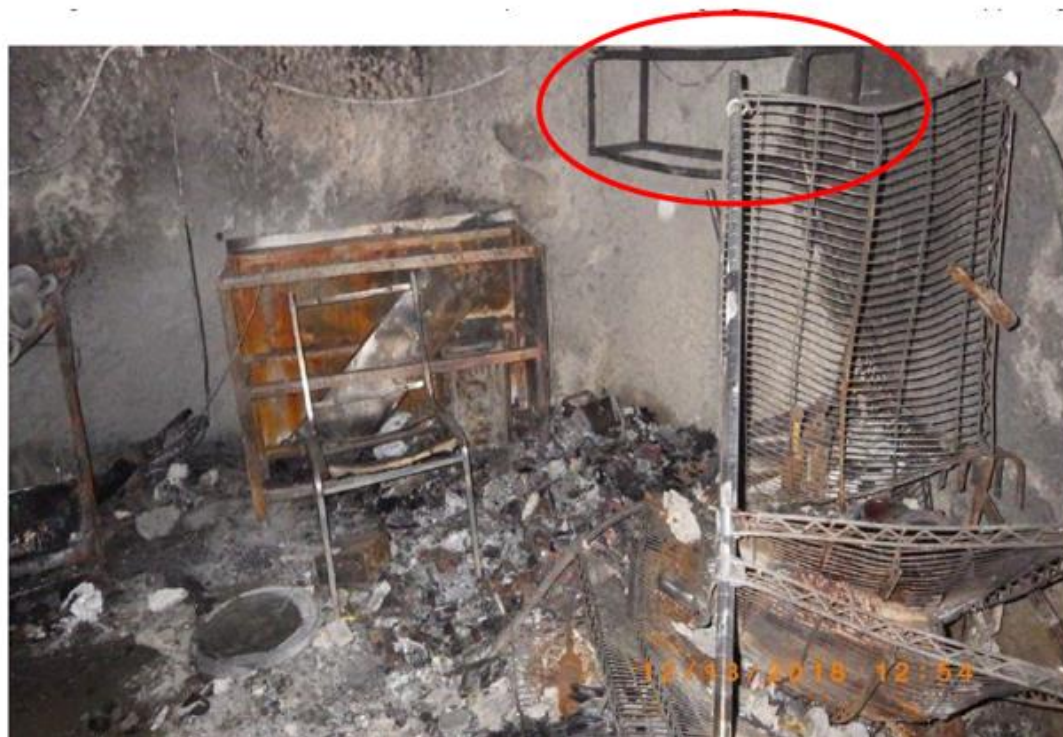
The charging location (shown below) was a wall-mounted steel frame with wooden shelves, on the left wall of the storage area. On the top shelf were 4 battery chargers (two 18-volt chargers on right, and two 28-volt battery chargers on left). The units were plugged into 2 power bars, which received power from a wall-mounted receptacle. The second shelf was use for lithium battery storage.

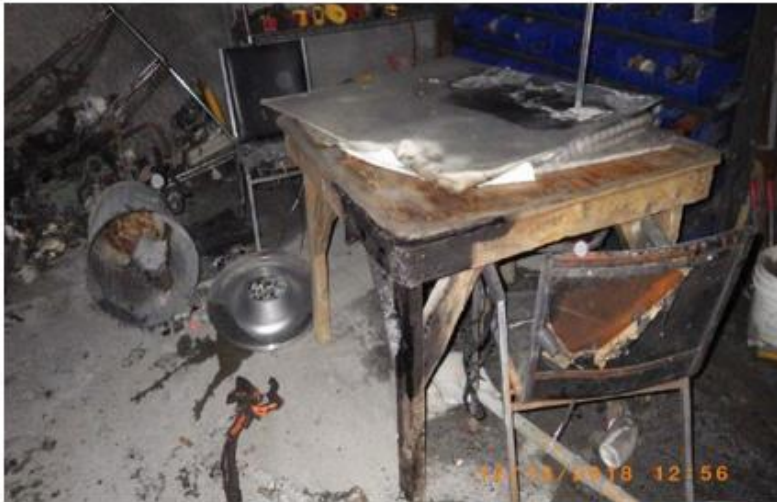
The fire originated in construction materials storage area 44-1 (Construction storage/work area). The area of origin was at the left rear of the drift, behind a locked steel door, parted by a 10-foot steel wall. The area had been unoccupied for in excess of an hour. The point of origin was a steel frame, wall-mounted assembly with 2 wooden shelves. The shelf contained several lithium-ion batteries and chargers. Some chargers were in use, and many batteries (both charged and uncharged) were piled on the shelf.

The charring of table faced the area of origin

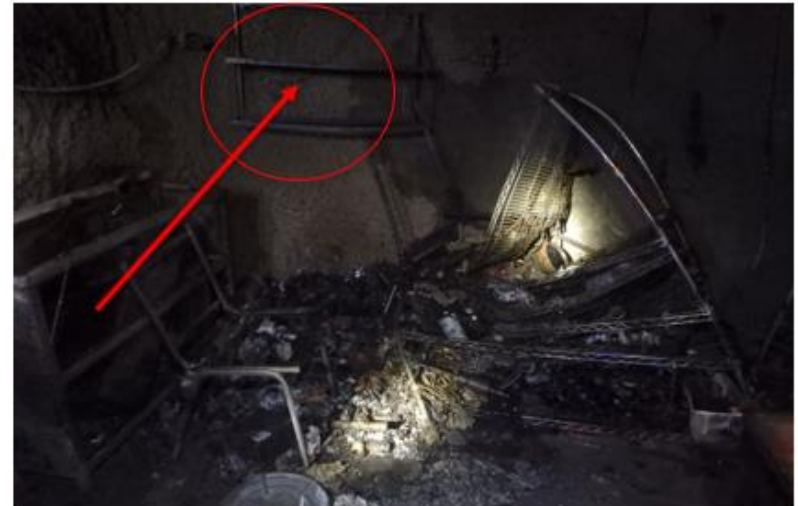
The steel shelf assembly hanging at area of origin

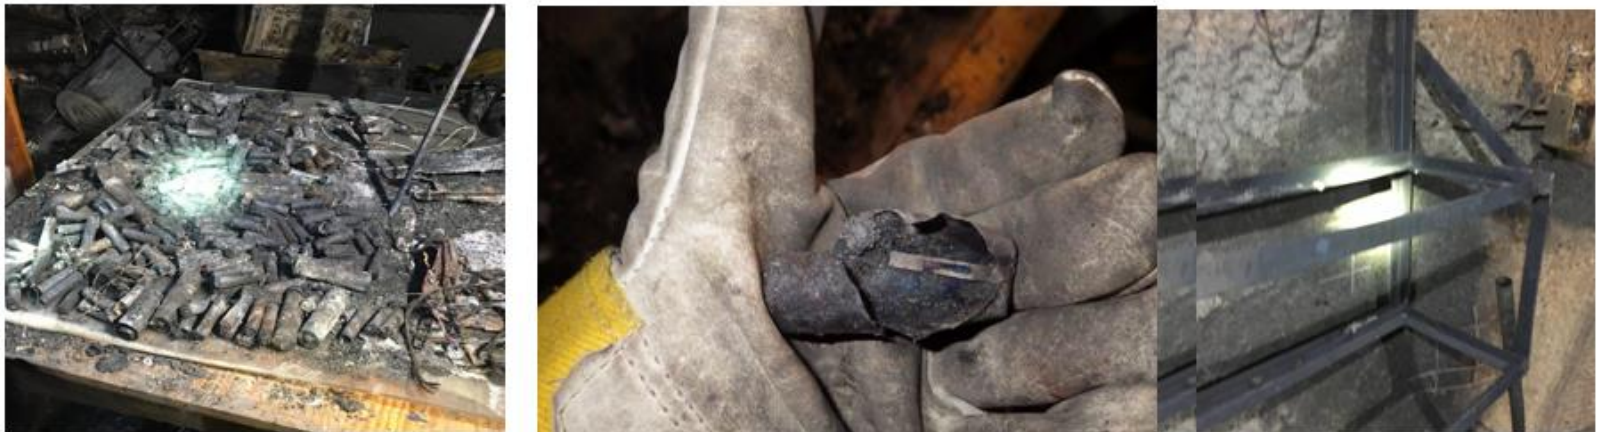
The cause of the fire was accidental, and was related to the battery-charging operation, chargers, power bar to lithium-ion battery, and battery storage method:

- **Charger:** Exposure to water, humidity, dust, and petroleum products, as well as manufacture defects, all increased the risk of fire hazard.
- **Power bar:** Not designed for charging application.
- **Batteries:** Subject to damage due to dropping from heights, contacts on batteries may have been exposed to dirt or petroleum products, or possible over-charging of the batteries, or extended life use.

Remains of lithium battery cells

- Examine the design and purchase approved cabinets for storage and charging of cordless lithium batteries.
- Source supplier for purchase of arc fault breakers and install at determined cordless lithium-ion battery group charging locations.
- Develop a cordless tool management procedure for site, and include the following safety factors:
 - purchase
 - use
 - charging and charging locations
 - battery storage
 - battery disposal
- Site-wide audit on cordless battery management.
