Fall of ground near scissor lift in underground mine

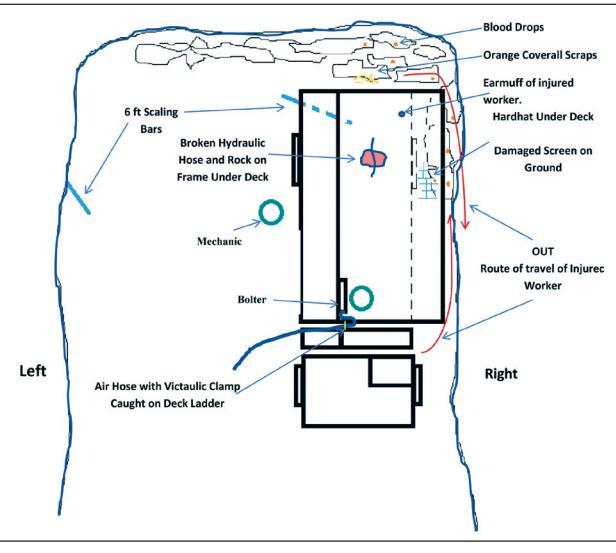
The worker was behind the deck near the right side when loose rocks fell from the face, striking the worker and pushing him into the back of the deck. The injured worker crawled out along the right wall, and was transported to hospital.

Planview showing incident location and scissor deck.

- Never work or go under unsupported ground; caution must also be taken with an unsupported face or wall.
- Always be on the lookout for changing ground conditions; check scale frequently.
- If equipment breaks down before ground support has been installed or where other hazards exist, it should be moved to a safe location. Where the equipment cannot be readily moved, a non-routine hazardous task may have to be developed.
- Always follow proper ground control communication procedures to report unusual ground conditions.
