HAZARD ALERT!

Work safely around guardrails – never reach through or over top

Source: WorkSafeBC

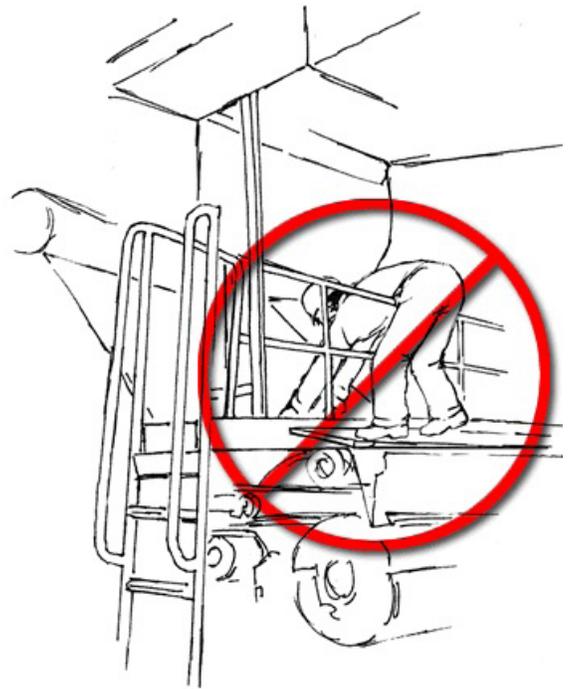
A machine tender was found pinned in the ingoing nip point of a press. He died from massive crush injuries..

There was no witness to this accident. At the time of the accident the paper machine was about to start up following a paper break. The presses were still running and the paper was being prepared for startup. Guardrails were in place around the paper machine. It is unclear how the victim fell into the nip point of the press. He may have been reaching into or over top of one of the guardrails.

- Provide written safe work procedures to each worker and do not rely exclusively on the “buddy system” to train workers.
- Review job safety breakdown for each worker on a regular basis and update any deficiencies.
- Reinforce guardrail safety requirements and monitor to ensure that all workers follow these requirements.
