UG Fire Construction Storage 44 Level

Red Lake Gold Mines
April 2019

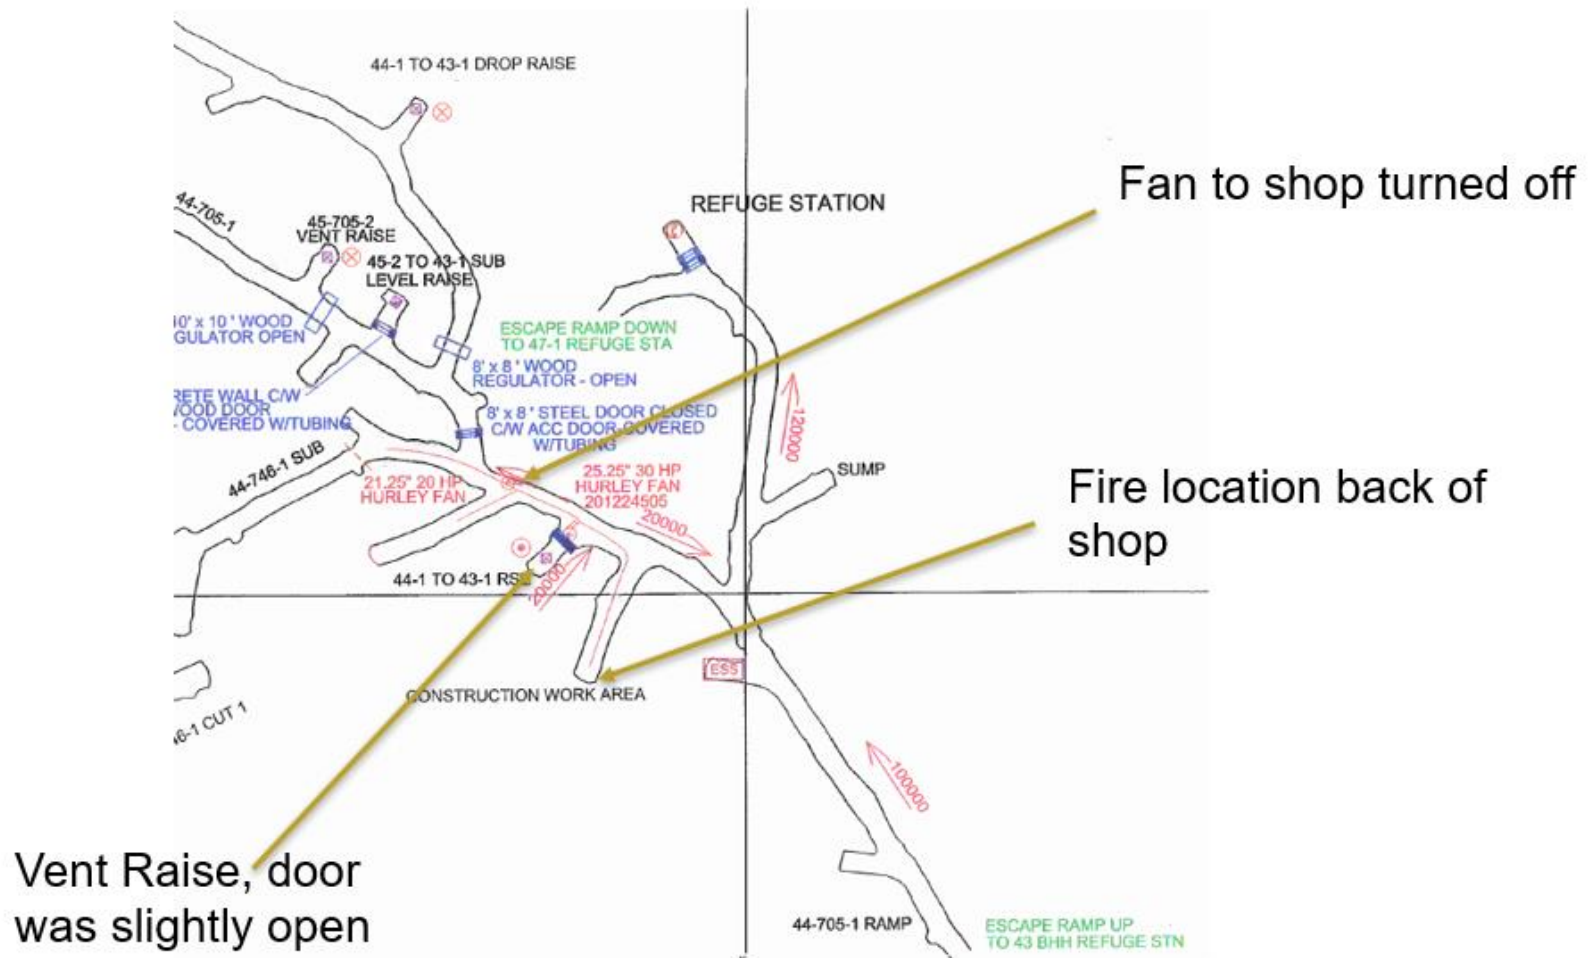
Level Plan?

- At approximately 18:30 hrs. on December 6, 2018, three workers were on route to the 4400-level construction storage/work area to gather their work gear. When the workers arrived at 4400-level, they smelled smoke.
- Two workers proceeded towards the back of the construction storage area, both with a 10lb fire extinguisher in hand to further investigate.
- The third worker was instructed to proceed to the 4500-level refuge station and contact Security to instruct them to stench the mine. The worker remained in the refuge station, awaiting further instructions.
- As the two workers approached the back of the storage bay, they noticed a large flame. The workers attempted to extinguish the fire with no success. With increasing smoke in the area, the workers left the area to seek refuge.
- All mine complexes were stenching, and Mine Rescue was deployed.

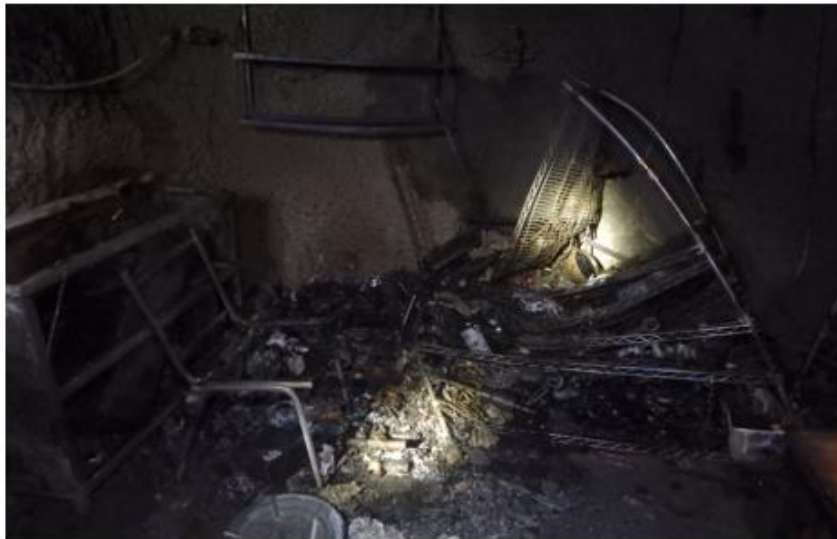
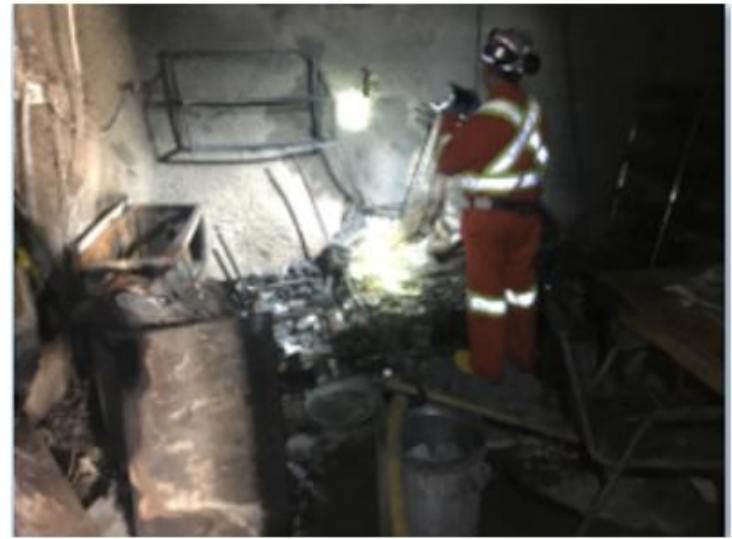
Third party investigators from the firm *Origin and Cause*, alongside the Red Lake Safety Team, completed an extensive investigation into this fire and determined the origin and cause of this fire.

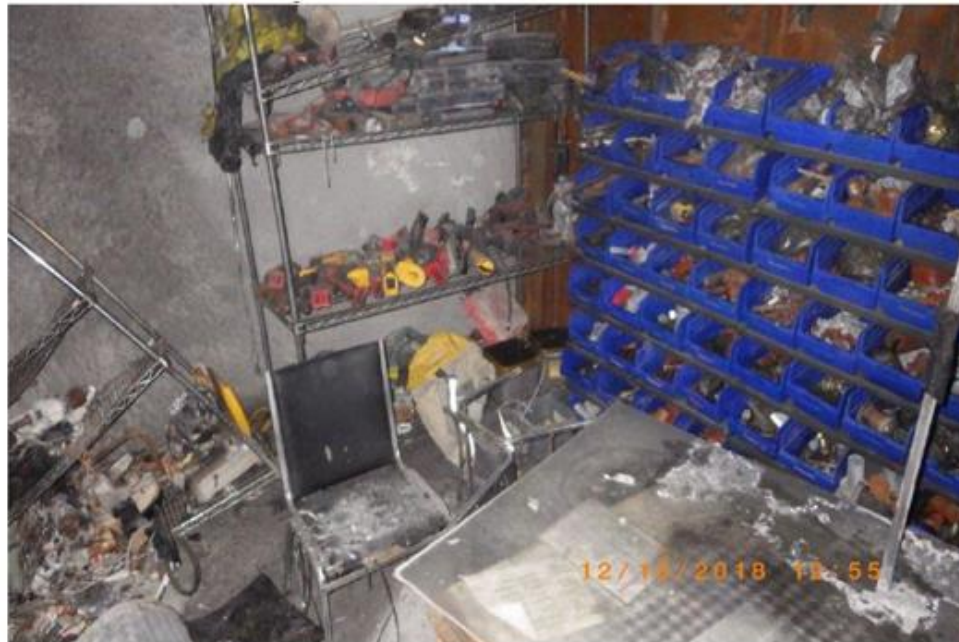
During dayshift on December 6, 2018, the storage/work area on 44-1 level was occupied by one worker who was constructing a steel pastefill insert. Throughout the shift, multiple workers entered the work area to pick up materials and tools (some were cordless). At the end of the shift, the crews returned the tools to storage and placed two lithium batteries on charge on a charging station located in the storage area.

The charging location (shown below) was a wall-mounted steel frame with wooden shelves, on the left wall of the storage area. On the top shelf were 4 battery chargers (two 18-volt chargers on right, and two 28-volt battery chargers on left). The units were plugged into 2 power bars, which received power from a wall-mounted receptacle. The second shelf was use for lithium battery storage.

- Examine the design and purchase approved cabinets for storage and charging of cordless lithium batteries.
- Source supplier for purchase of arc fault breakers and install at determined cordless lithium-ion battery group charging locations.
- Develop a cordless tool management procedure for site, and include the following safety factors:
 - purchase
 - use
 - charging and charging locations
 - battery storage
 - battery disposal
- Site-wide audit on cordless battery management.
