# HAZARD ALERT

## Equipment operator crushed to death by feed rollers

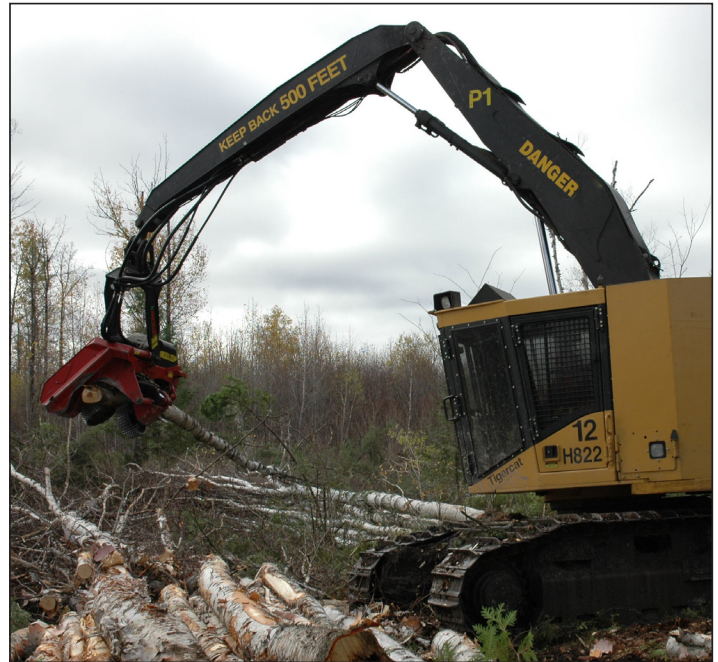
The processor head was resting on the ground in the upright position. The owner-operator was inside the processor head, with his head and shoulders between the feed rollers that guide the logs into the processor head. As he attempted to manually remove the spring-loaded measuring wheel, a co-worker assisted from outside the processor head with a pry-bar. Shortly after the owner-operator started to pull on the measuring wheel, the feed rollers closed and pinned him, crushing his head and upper shoulders.

The failure to shut down and lock out the hydraulics and the electronic components before performing maintenance was the major contributing factor in the fatality. Any movement of the measuring wheel could have sent a signal back to the computer, automatically triggering a command to the feed rollers.

Maintenance work must never be done on equipment unless the equipment is shut down, locked out, and in a zero-energy state. If this simple but crucial rule of occupational health and safety had been followed, the fatal incident would not have occurred.

Even in extremely cold weather, when machinery needs to be warmed up in order to function properly, the only safe way to do maintenance work is with the equipment shut down and

locked out. In this case, the cut-to-length processor should have been started up only after the work on the measuring wheel was completed. If there is any doubt about how to perform repairs or maintenance work, the owner's manual should be consulted and, if necessary, the work should be done by more qualified personnel.
