Hazard Alert

Head-on collision on single lane bridge

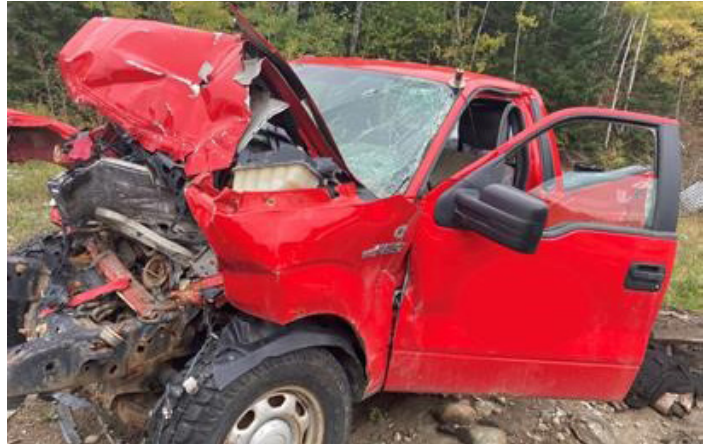
4. The two vehicles collided head-on on the bridge, with the log truck pushing the pickup truck back across the bridge to the other side. Log truck Driver 1 was not physically injured, but the pickup Driver 4 sustained a broken hip, broken ribs, and a broken sternum.

The log truck pushed the pickup truck back across the single lane bridge.

- All posted speed-limit signs on forest access roads and highways must be followed and enforced. Companies need to communicate and enforce their policy on speed limits to all drivers, with special emphasis on the importance of adjusting speed to road and weather conditions. Drivers must always be ready to safely share the road on short notice.
- Radio communication with other drivers is a useful tool on logging roads, but drivers must not rely only on their radio to determine if the road is clear of traffic. Other vehicles, including those driven by members of the public using the road for recreational purposes, may not be equipped with two-way radios. Even when a system of two-way radio communication is in place, a radio may malfunction, and communication may be interrupted.
